WORKS INSPECTION & TESTING Bulk Earthworks

**PROPOSED
RESIDENTIAL
DEVELOPMENT**

**(STAGE 1) 409-429
PARK RIDGE ROAD**

JOB NO: P743 comp01

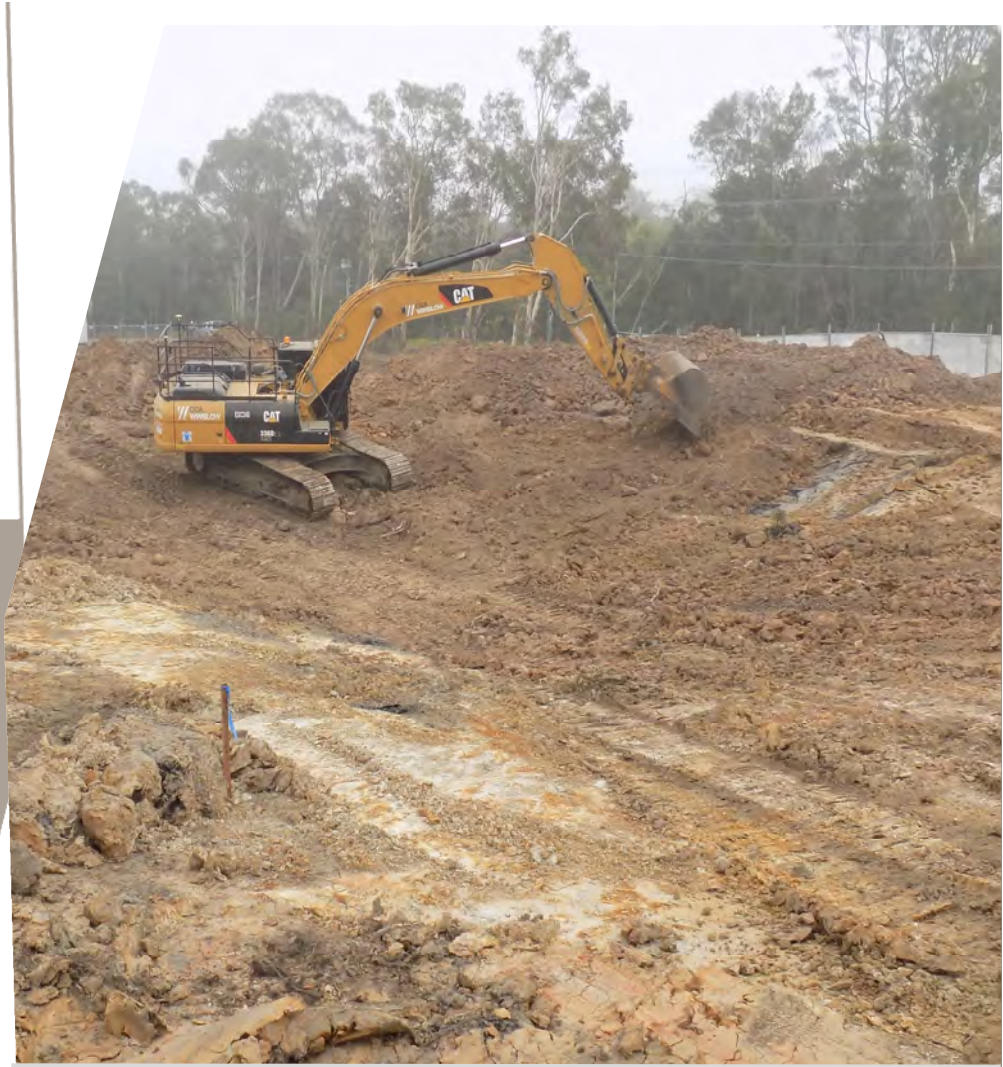
BULK EARTHWORKS FILL

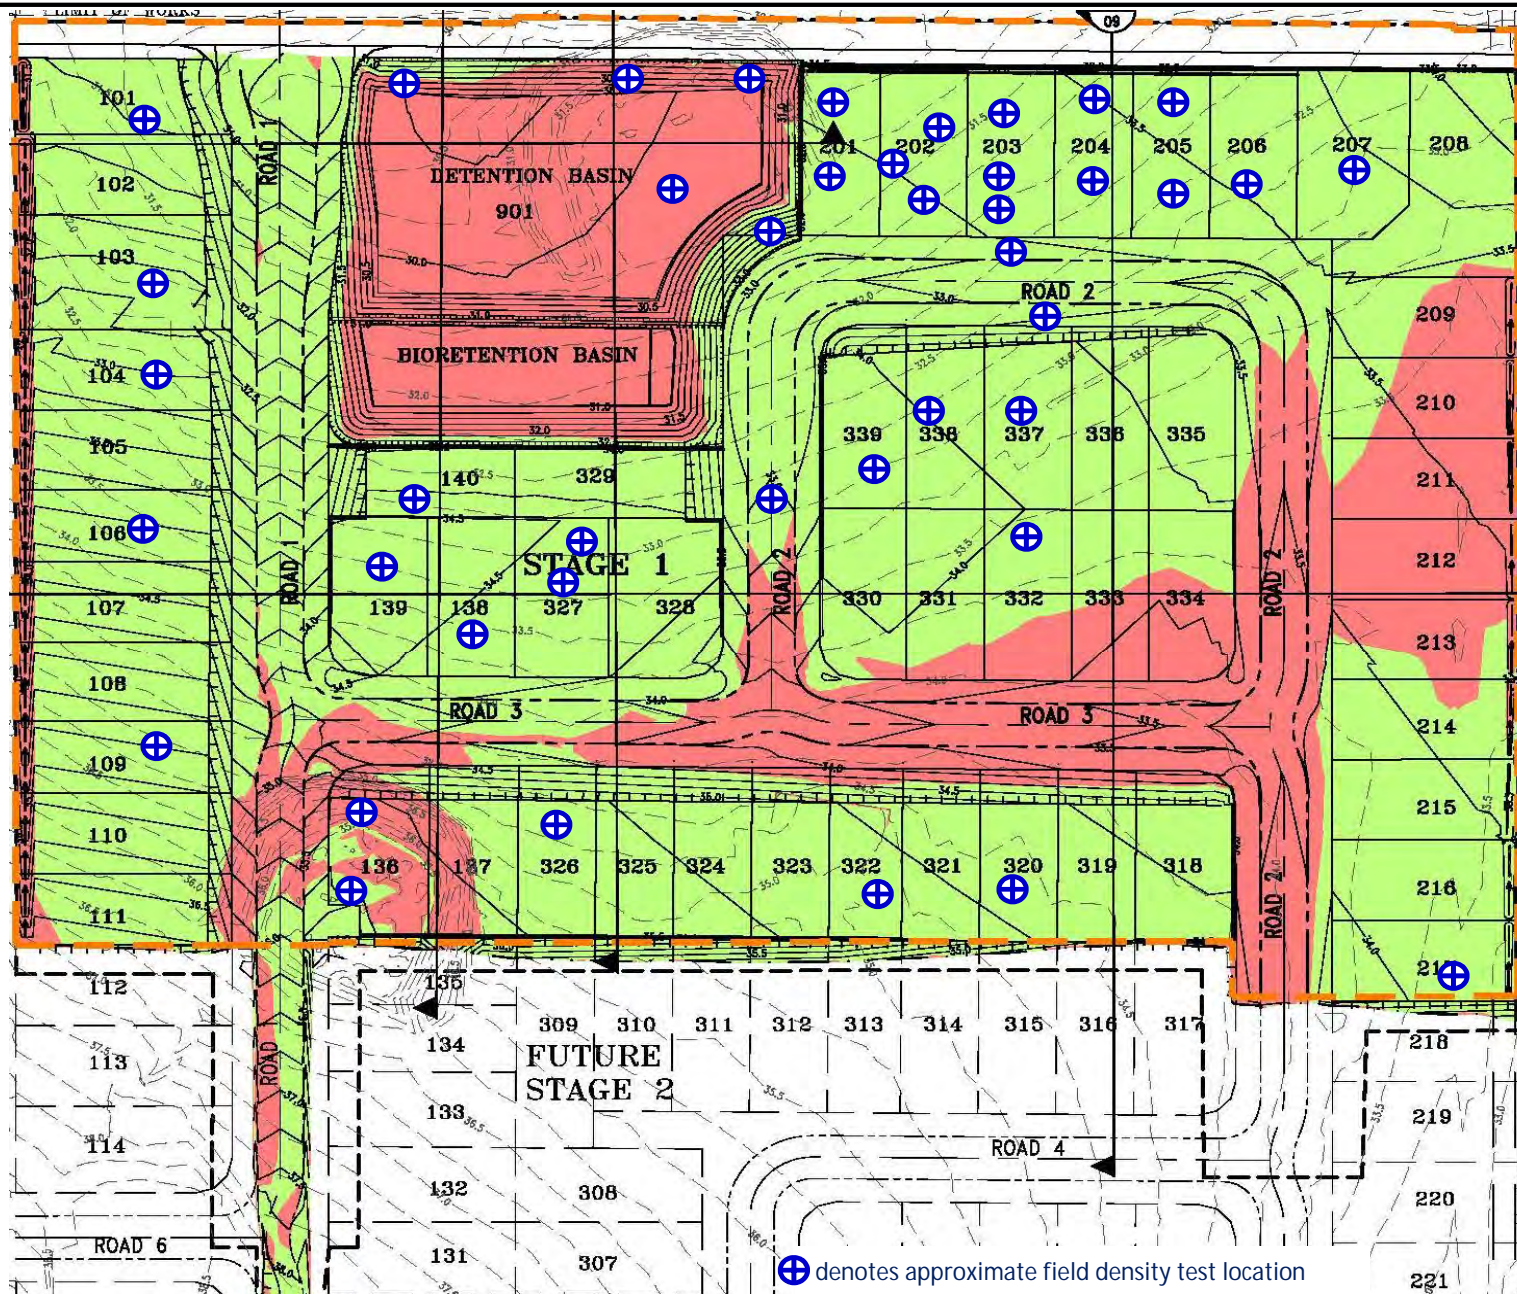
DRY DENSITY RATIO / MOISTURE RATIO REPORT

Client:	CCA Winslow	Report Number:	13385/R/17951-1
Client Address:	1587 Ipswich Road, ROCKLEA	Project Number:	13385/P/743
Project:	409-429 Park Ridge Road (Stage 1)	Lot Number:	-
Location:	Park Ridge	Internal Test Request:	13385/T/10592
Component:	Bulk Earthworks Fill	Client Reference/s:	1/08/2017
Area Description:	Bio Basin	Report Date / Page:	4/08/2017 Page 1 of 1
